# ELEMENT 2030

## STORMWATER MASTERPLAN FOR ASHTON

**OUR REF NO. 1800561  
SEPTEMBER 2018**

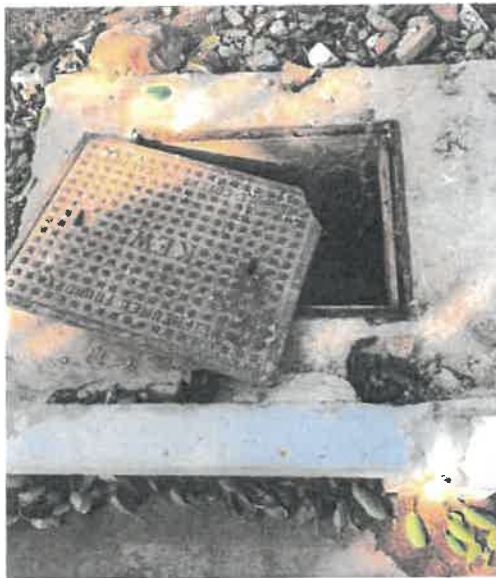
**Figure 3.1: Damaged Inlet In Mketsu Street (Node D20.25.1)**

Overall maintenance and cleaning of the stormwater inlets such as catchpits, grid inlets and wing walls, is required as a moderate amount of these were clogged with litter or silted up. However, a maintenance team was busy cleaning the infrastructure during the survey stage of this project in the Zolani area. See figures 3.1 to 3.4.

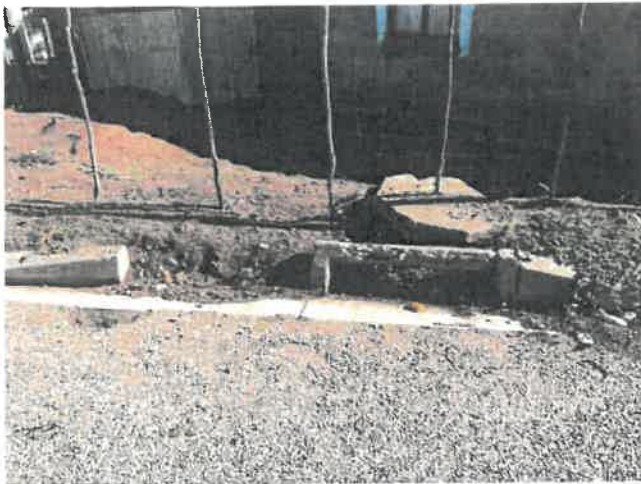
**Figure 3.2: Damaged/Abandoned inlet in Ndinisa Street (Node D21.8.7.1.1)**

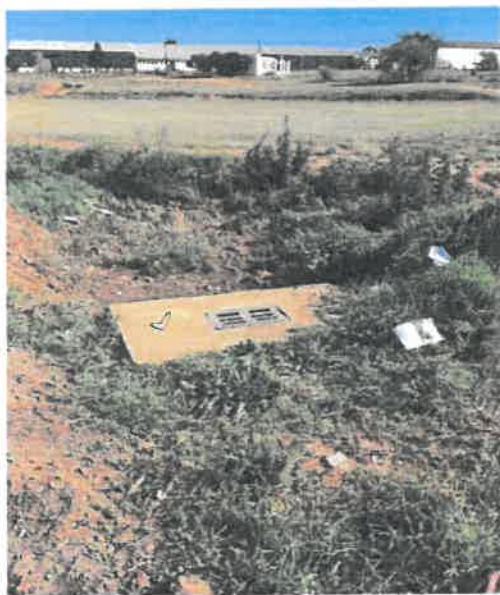
**Figure 3.3: New headwall structure with grid inlet in top slab (Node J2)**

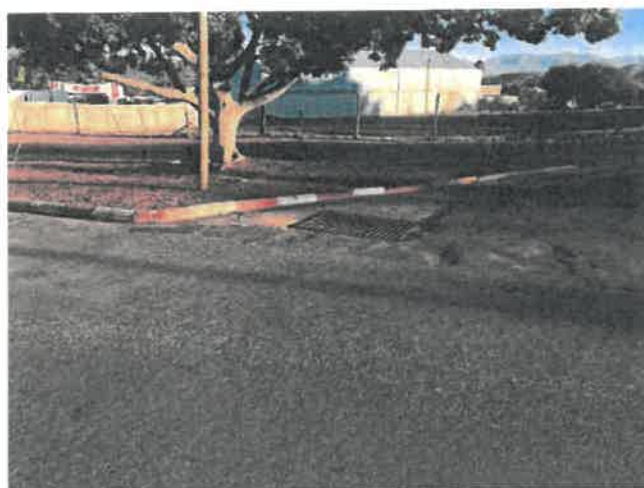
**Figure 3.4: Grid Inlet in Faure Street (Node D8.9.4)**

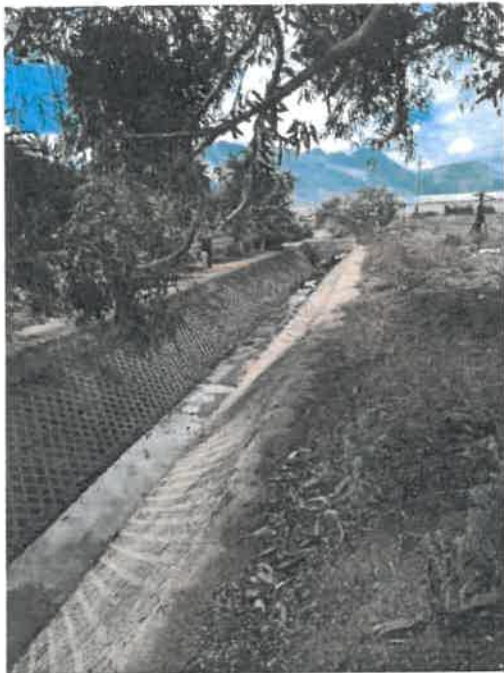
**Figure 3.5: Amorfex channel adjacent to the railway (Conduit C7.10)**

Maintenance on the conduits such as open channels and culverts seemed good as very few of these were clogged or contained debris. See figures 3.5 to 3.8.

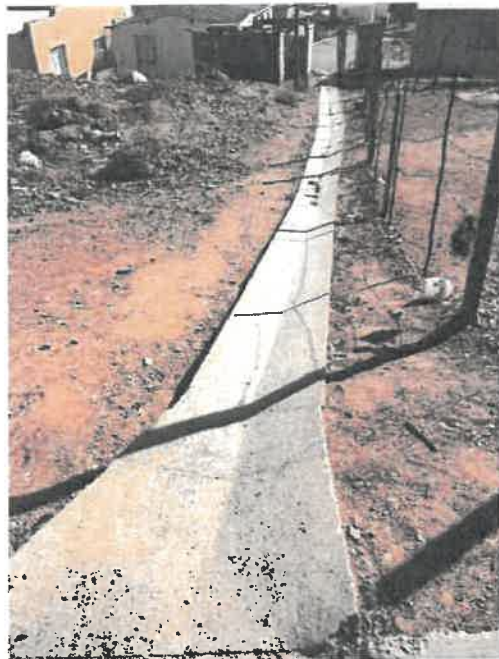
**Figure 3.6: Dish channel between Matotl Avenue and Ntantiso Close (Conduit C21.8.12)**

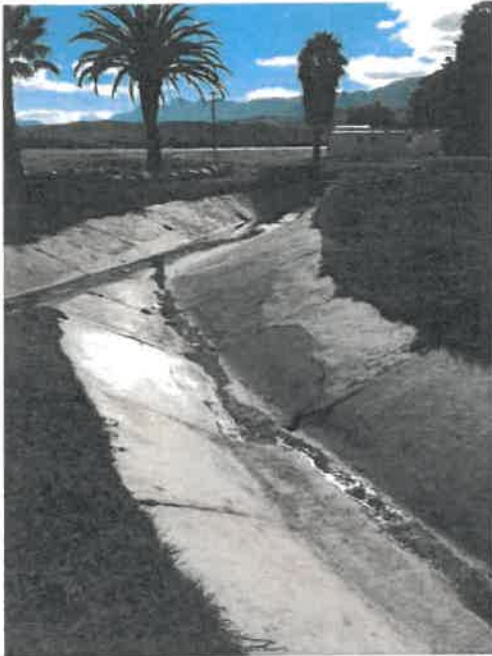
**Figure 3.7: Open concrete channel adjacent to R60 (Conduit C20.2)**

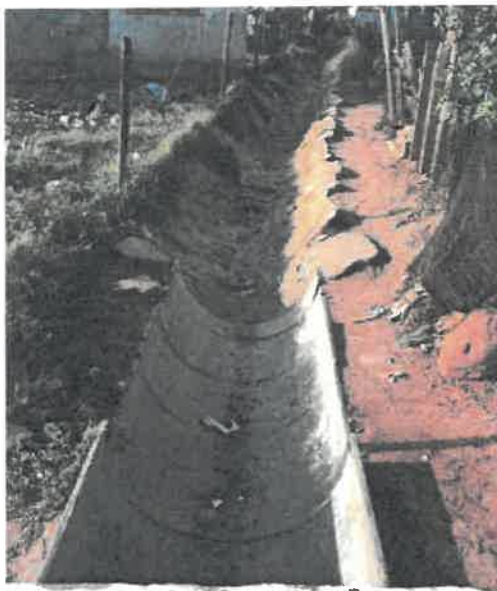
**Figure 3.8: Pipe and stone pitch channel between Tyhalisisu and Maqolo Streets (Conduits C20.5 & C20.4)**
