# **WATER DEMAND MANAGEMENT AND WATER CONSERVATION STRATEGY (WC/WDM) FOR MONTAGU, ROBERTSON, McGREGOR, ASHTON & BONNIEVALE IN LANGEBERG LOCAL MUNICIPALITY**

**January 2014**

# EXECUTIVE SUMMARY

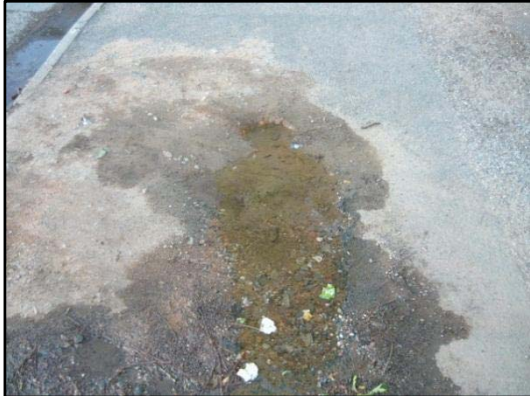
Ashton – Mains leak in unnamed street next to Ashton Police Station.

According to the municipality, and the based on observations by the project team there is currently minimal visible leakage on the water network. A few visual leaks were however identified as shown in Section 3.1.1.

Leak detection should be undertaken in the following zones where higher than expected night flows were measured:

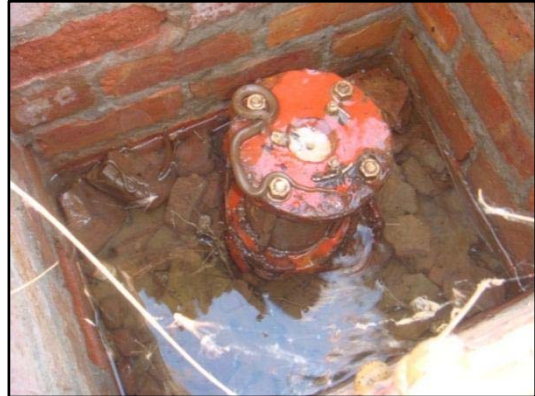
Ashton – Rooiwalde airvalve leaking, located near Rooiwalde bulk meter

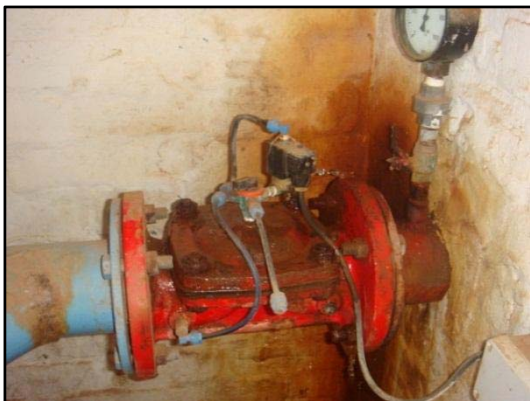
Robertson - Nkqubela PS – Leak on control valve circuit

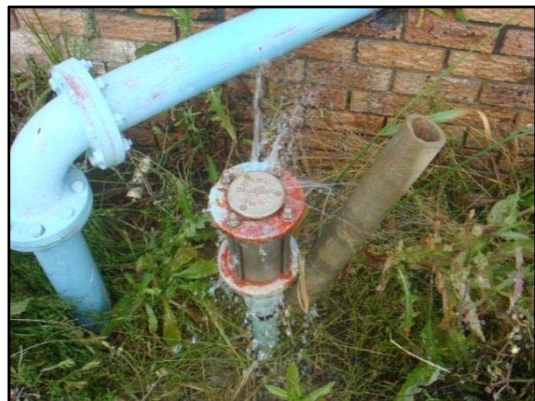
Montagu – Leak on airvalve located at Badshoogte PS, near Ashbury LL Reservoir

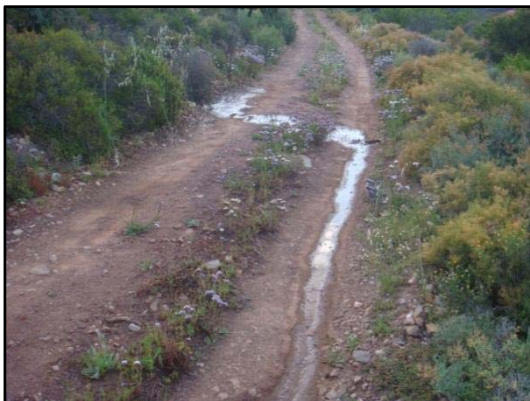
Montagu - Badshoogte Reservoir Outlet / Inlet leaking

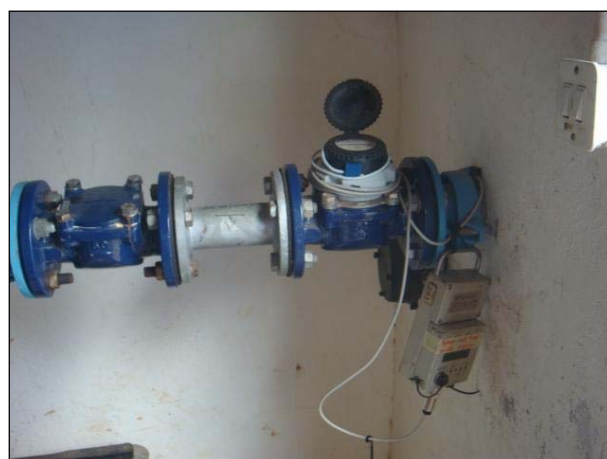
One of the useful tools that can be used to gain information on the system operation is logging of pressures and flows in selected points throughout the network. A logger is an electronic device that can be programmed to record flow on a bulk meter or pressure on a fire hydrant or tap. (**Figure 2 and Figure 3**) The logger can be programmed to save the flow and pressure data for any required interval (i.e. every 1 sec, 1 min, 15 min etc.) Once the required logging period has ended the data on the logger can be downloaded onto a computer for viewing and analysis.

Figure 3: Example of flow logging.
