## PROPOSED HOUSING DEVELOPMENT OF MANDELA SQUARE ON REMAINDER ERVEN 1 & 937

**REPORT NO. R01496**

PROPOSED HOUSING DEVELOPMENT OF MANDELA SQUARE  
ON REMAINDER ERVEN 1 & 937

TECHNICAL REPORT ON THE PROVISION OF  
CIVIL INFRASTRUCTURE SERVICES

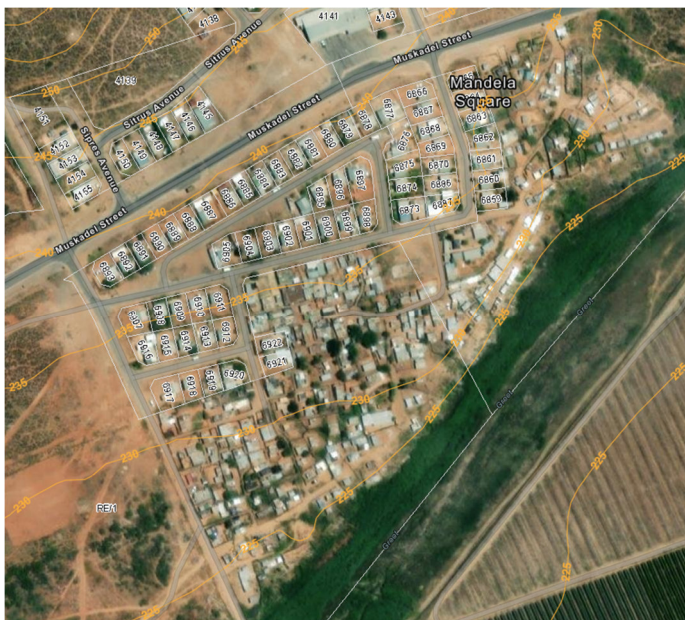
Figure 1: Site Topography

The topography of the area is characterized by gentle to moderate sloping terrains varying between 1:8 and 1:17, draining in a South Easterly direction into a watercourse to the South and is regarded as suitable for development.

Remainder Erven 1 & 937 (the site) is approximately 3.66 hectare in size and is currently occupied by informal Structures (shacks) and undeveloped grasslands.

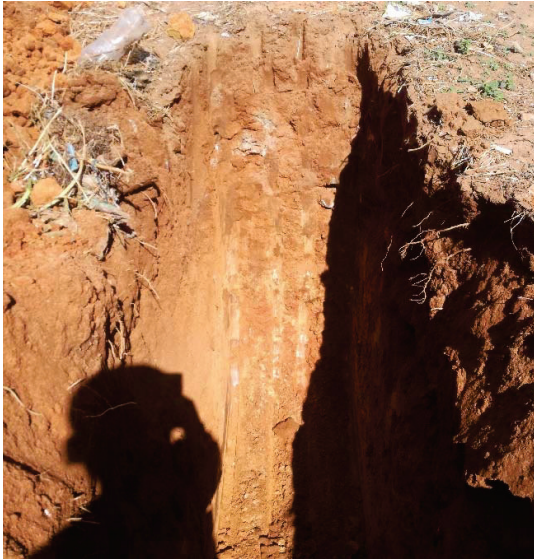
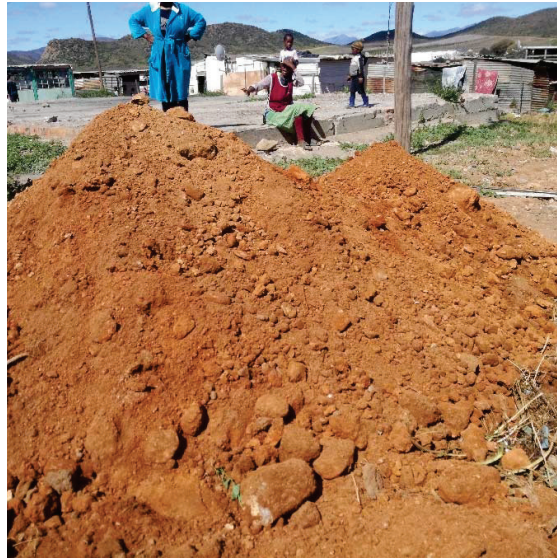
**Figure 6: Typical orange alluvial soil exposed in test pits**

Refusal of the TLB excavator was recorded on the basal rock or on alluvial boulders in all 6 test pits at depths varying from 0.65m to 2.0m (see **Figure 7**). The natural, insitu soils were generally dense at normal shallow founding depths (~NGL-0.6m) and were only slightly compressible/collapsible under light loads. Uncontrolled fill material that occurred on parts of the site (mainly northwest portion, near existing structures) was potentially highly compressible and highly unsuitable to carry even light structures. A summary of the test pit data and the thickness of the different soil horizons is provided in **Table 1**.

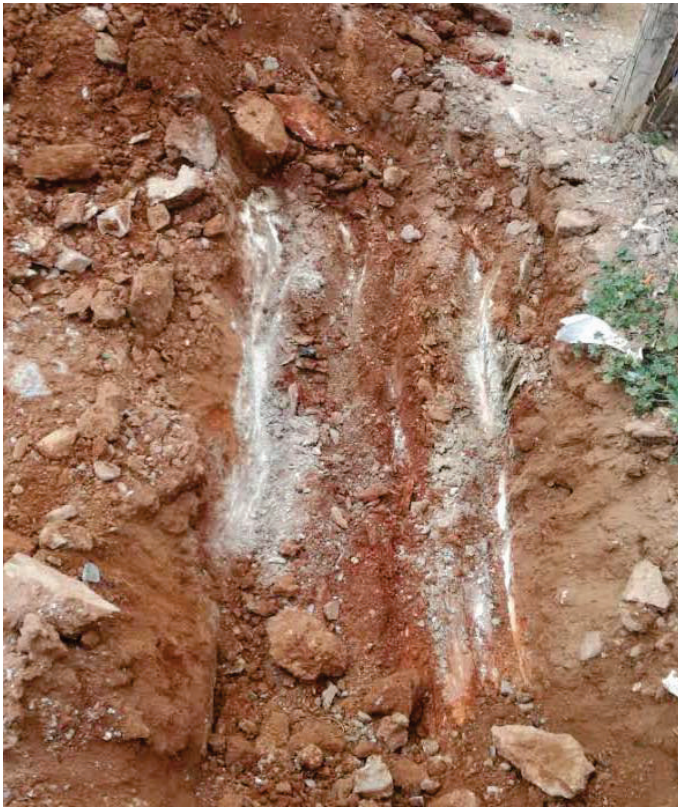
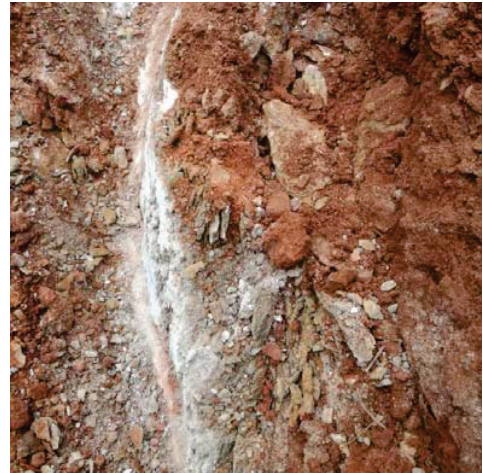
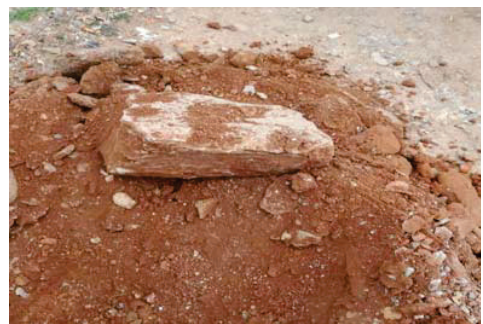
**Shallow bedrock encountered at TP3.**
