## The History of Cogmans Kloof

## All about the Cogmans Kloof Interpretive Signs...

The highly informative signage along the road through Cogmans Kloof was commissioned as part of the recent extensive upgrade and realignment of the R62 between Ashton and Montagu.

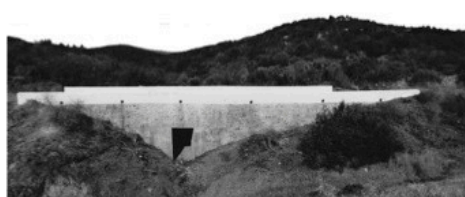
Hodges Bridge, circa 1950, was for many years affectionately referred to as 'Hortjesbrug' by the district's residents.

Hodges Bridge actually consists of two bridges, or what are known today as culverts.

Each bridge, built with stone masonry, has a rectangular opening for the watercourse. The bridge decks (or roofs of the rectangular openings) were made of Yellowwood beams but have since been partially replaced and supported with reinforced concrete.

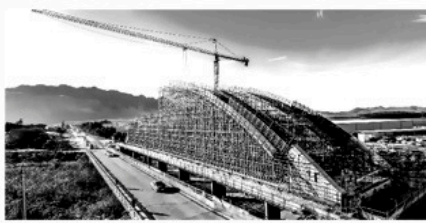
A view of the new Ashton Arch under construction, with the previous bridge still in use.

The new Ashton Arch is a tied-arch bridge. The roadway deck is carried by steel hanger cables suspended from the two reinforced concrete arches, while each arch is anchored by a horizontal tie-beam located between the road lanes and the pedestrian paths. Since the bridge is self-anchored with its forces in balance, it allowed the bridge to be constructed in a temporary position adjacent to the road and then moved transversely into its final position. This ensured minimal disruption to traffic during the bridge construction.

A key improvement of the new bridge is the absence of supports in the river. Due to the arch form, the new bridge has a single span of 110m, which significantly improves the hydraulic performance when compared with the previous four large piers that supported the historic bridge.
