# Engineering Geological Report

Robertson Fire Station

Robertson

| <b>Project No:</b> | TG-21-030 |

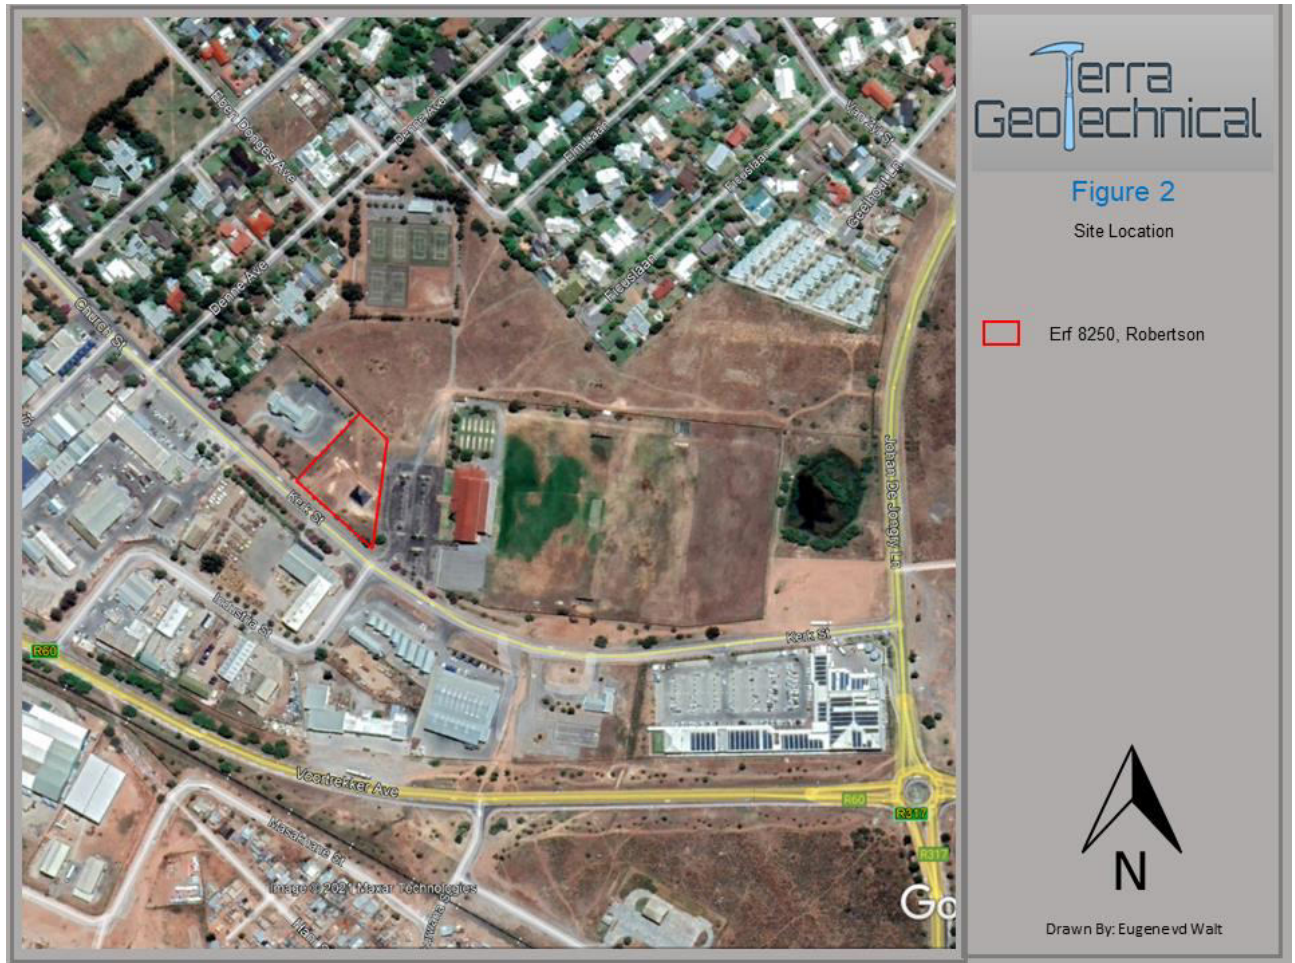
**Figure 2** below, graphically depicts the site location

The site is defined as an irregular shaped parcel of land on the western side of the Callie de Wet Sport Grounds. The site is known as erf 8250 and is approximately 0.5 ha in size. On the surface, the site hosts a single concrete and masonry infrastructural unit, whilst subsurface services (water, sewer, electricity) traverse the site.

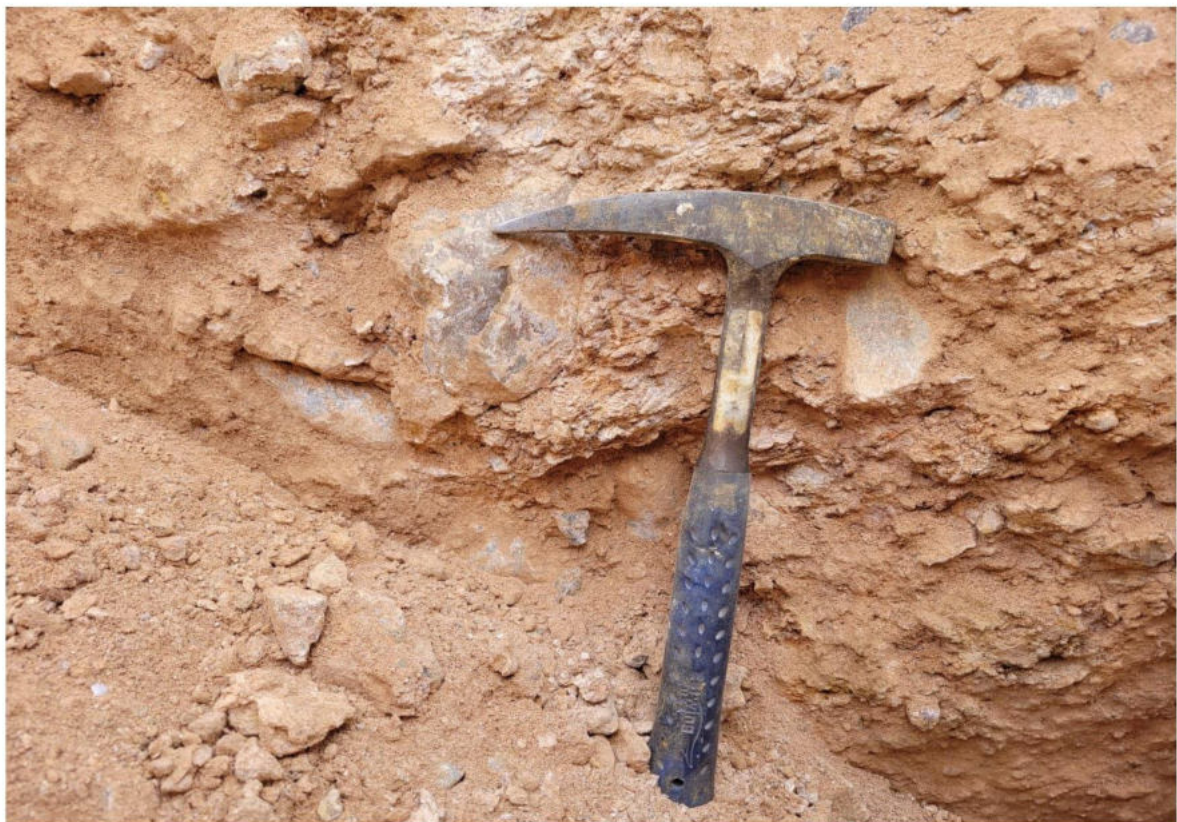
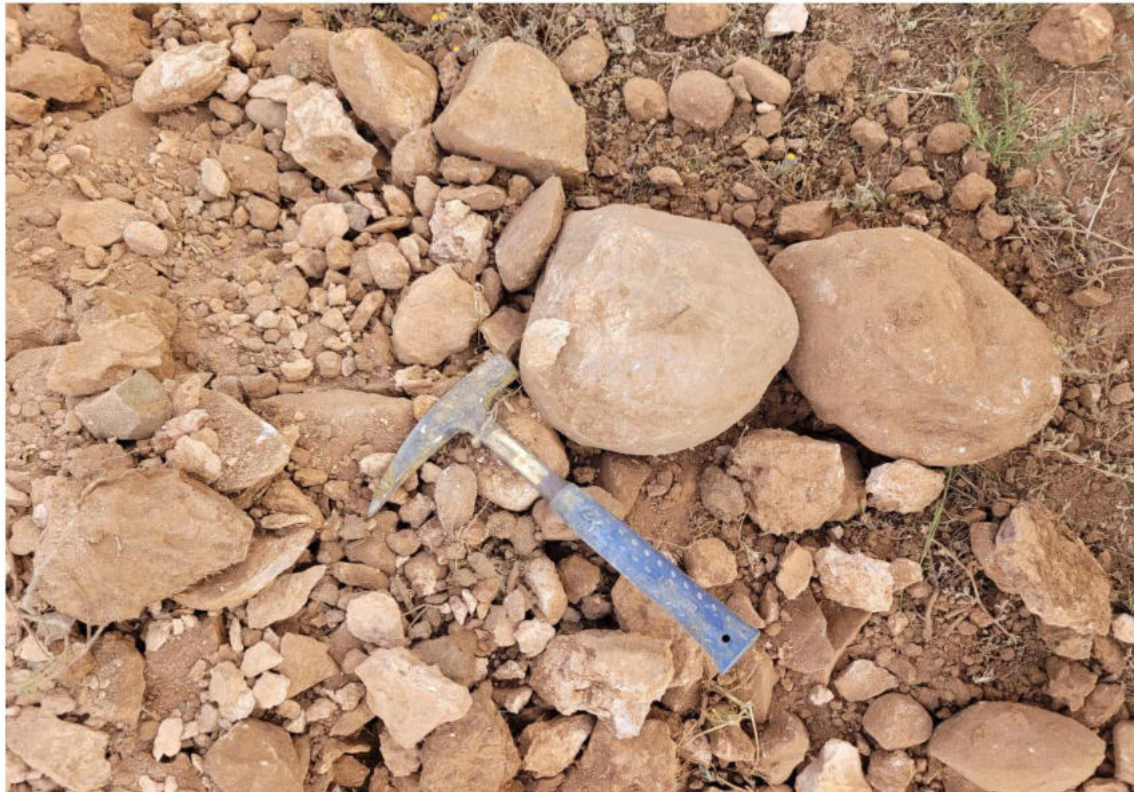
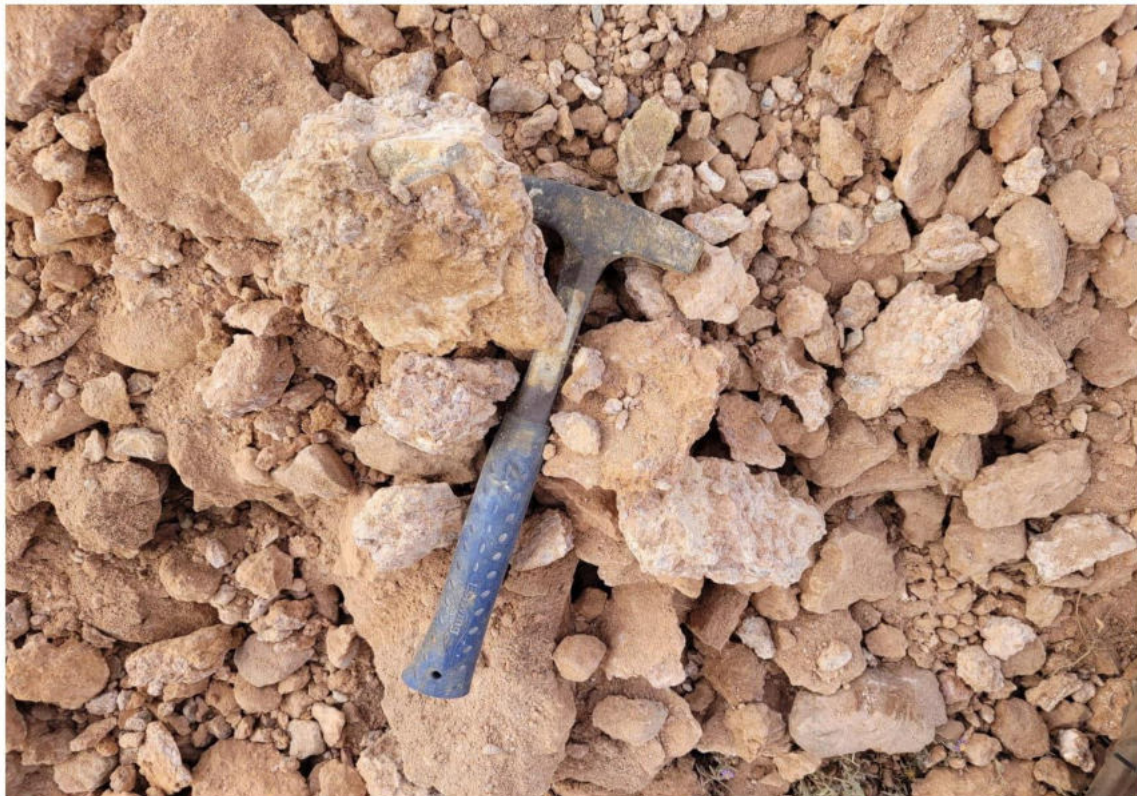
Excavated Material Test Pit TP3

Generally, no problems are foreseen during the excavation of shallow foundation trenches or deep service trenches to a depth of 1.5 m below natural ground level, through the use of a mechanical excavator of similar size and strength to what was used during the investigation, however, localized difficulty in excavation was encountered within TP3 from a depth of 1.4 m.

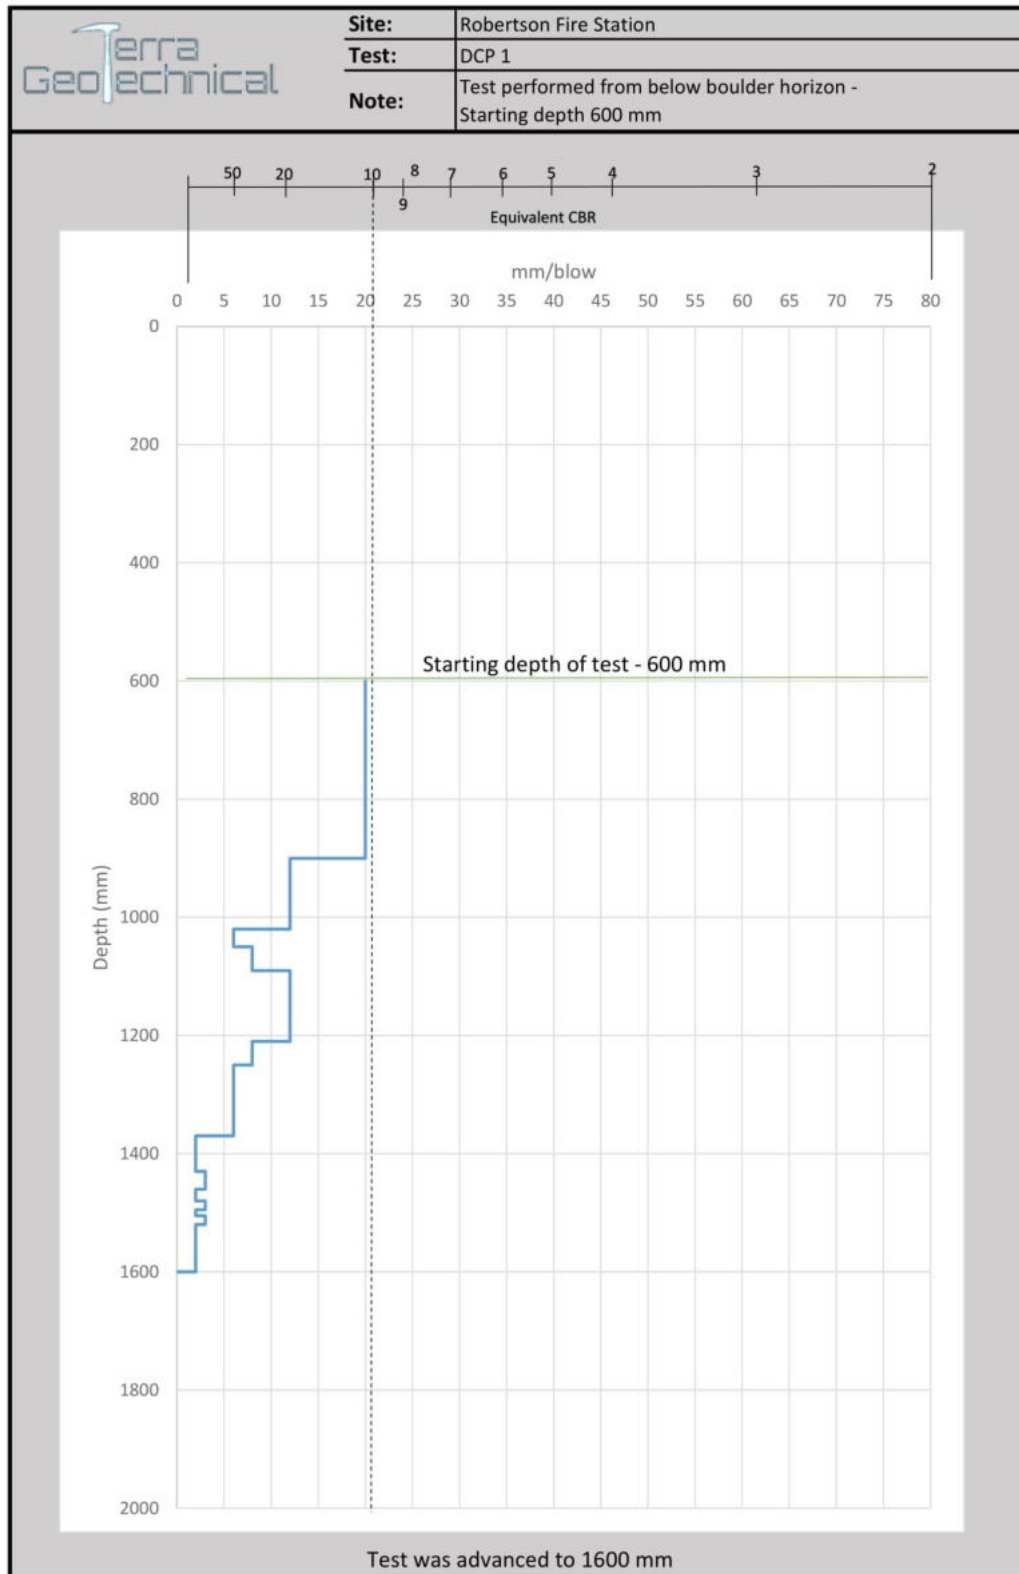
# **DCP Test Results**

A total of 5 DCP tests were carried out across the site to assess the consistency of the in-situ sub-soils and provide an indication of the founding conditions beneath the site.

The results of the DCP test indicate that the residual material underlying the site exhibits moderate to high CBR values. The lab tests on this material however, yielded much poorer CBR results. The major contributing factor to this difference is that the DCP test is done at in-situ moisture conditions, whereas the laboratory tests are conducted at saturated moisture conditions.

The DCP test that was advanced into this horizon yielded CBR results in excess of 15, indicating a competent horizon, whereas the lab results of the compacted material only reached a CBR of 3 at a compaction effort of 100%. The major contributing factor for this large difference in strength, is that the lab sample was tested under saturated conditions and the on-site tests were conducted at natural moisture conditions. This is clear evidence that the material strength characteristics will change greatly when inundated with water.
