PHASE I GEOTECHNICAL SITE INVESTIGATION

MCGREGOR HOUSING ERF360

FOR ASLA DEVCO (PTY) LTD

Date: May 2013 Project no: 066-13 **Contents** Page **Executive Summary** 1 Introduction and terms of reference 2 1. Information used in the study 2 2. Site description 2 3. Nature of investigation 4. 4 4.1 Test pits and DPL (Dynamic Probe Light) tests 4 4.2 Laboratory testing 4 Site geology and groundwater conditions 4 5. 5.1 General 4 5.2 Soil profile 4 5.3 Water table 4 6. Geotechnical evaluation 5 6.1 Engineering and material characteristics 5 6.2 Slope stability and erosion 6 6.3 Excavation Classification with respect to Services 6 6.4 Impact of the Geotechnical Character of the Site on Subsidy Housing Developments 6 7. Site classification 6 Foundation recommendations and solutions 8. 7 Drainage 9. 7 10. Special precautionary measures 7 11. Conclusions 7 Appendix A: Site Plan and Site Class Designations

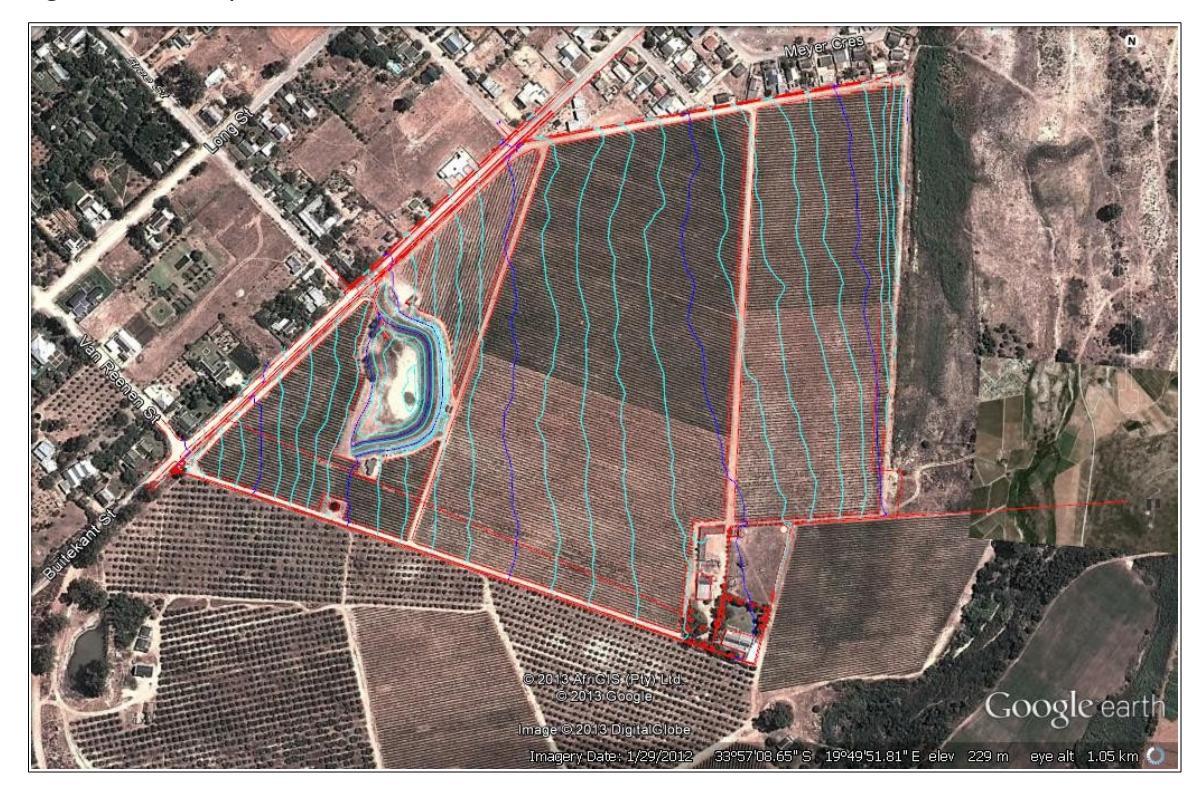
Figure 2: Topography of site

The location of the site relative to the town of McGregor is shown in Figure 1, and its topographic setting is shown in the remote image, Figure 2.

Topographically, the site is relatively flat with a slight slope to the east, where a wetland has developed adjacent the site. A small earth dam is located on the eastern section.

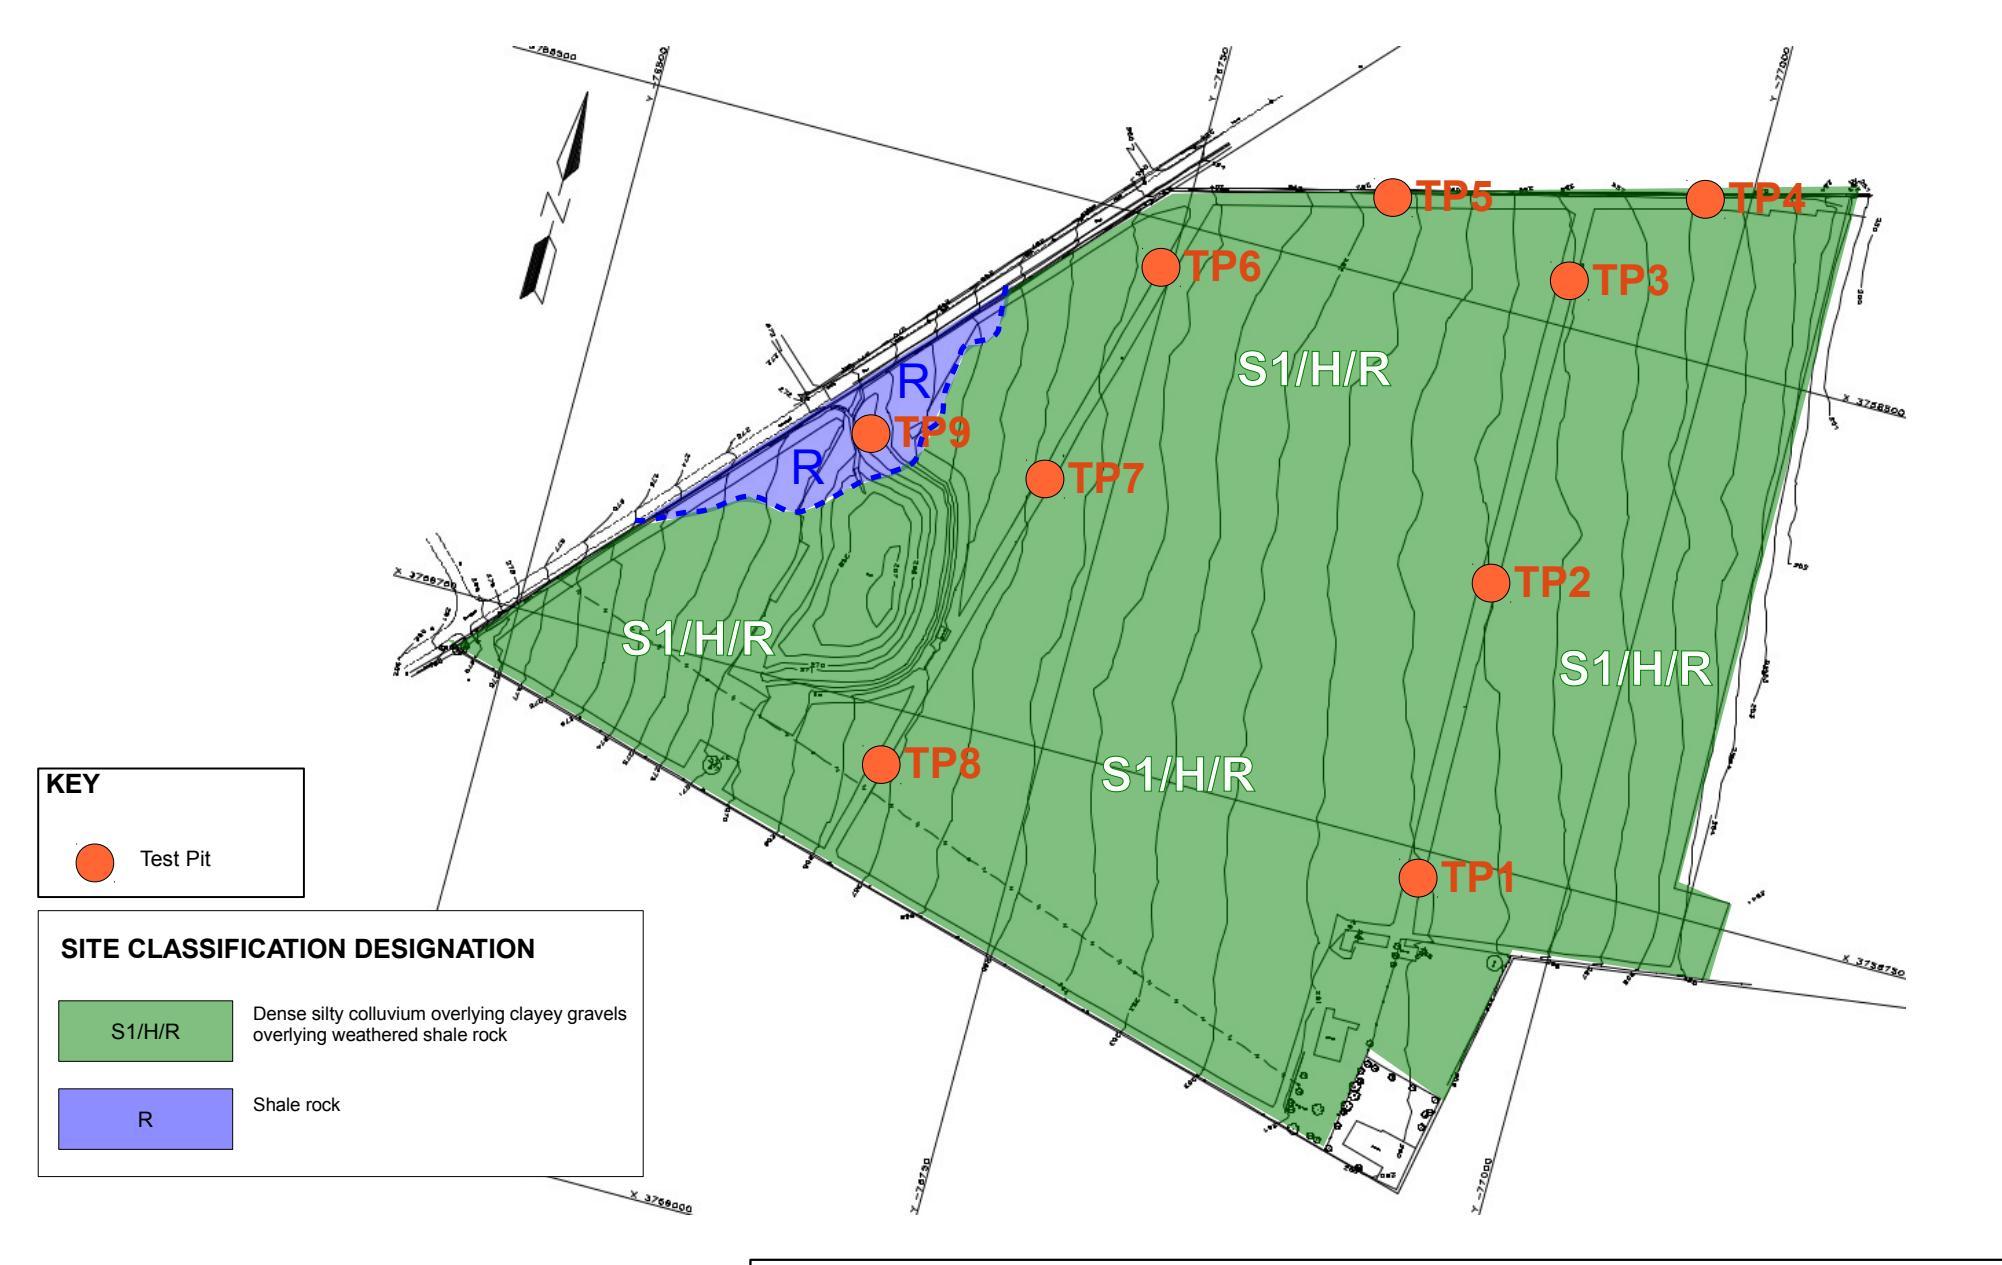
CLIENT	CLIENT: ASLA DEVCO (PTY) LTD								
PROJE	PROJECT: MCGREGOR HOUSING ERF360								
TITLE: SITE PLAN SHOWING TEST PIT POSITIONS AND SITE CLASSIFICATION									
DATE: May-13 SCALE: NTS TRACED BY: SS FIG.NO. 1 JOB NO. 066-13

In terms of the Residential Site Class Designation, the site has been classified as S1/H1/R, H1/R and R in three delineated areas..

Test pit locations are shown on the site plan in Appendix A (Figure 3). Copies of the recorded test pit soil profiles included in Appendices B.

The site has a soil profile of colluvial and residual soils overlying weathered shale rock, as outlined in Table 7.1. The engineering design requirements applicable to this site class designation in relation to foundations are detailed in Section 8.

Site Classification	Character of Founding materials	Expected Range of Total Soil Movements (mm)	Assumed Differential Movement (% of Total)	Maximum Allowable Bearing Pressure (kPa)
S1/H1/R	Dense silty colluvium overlying clayey gravels overlying weathered shale rock	<15	50	200
R	Shale rock	-	50	500

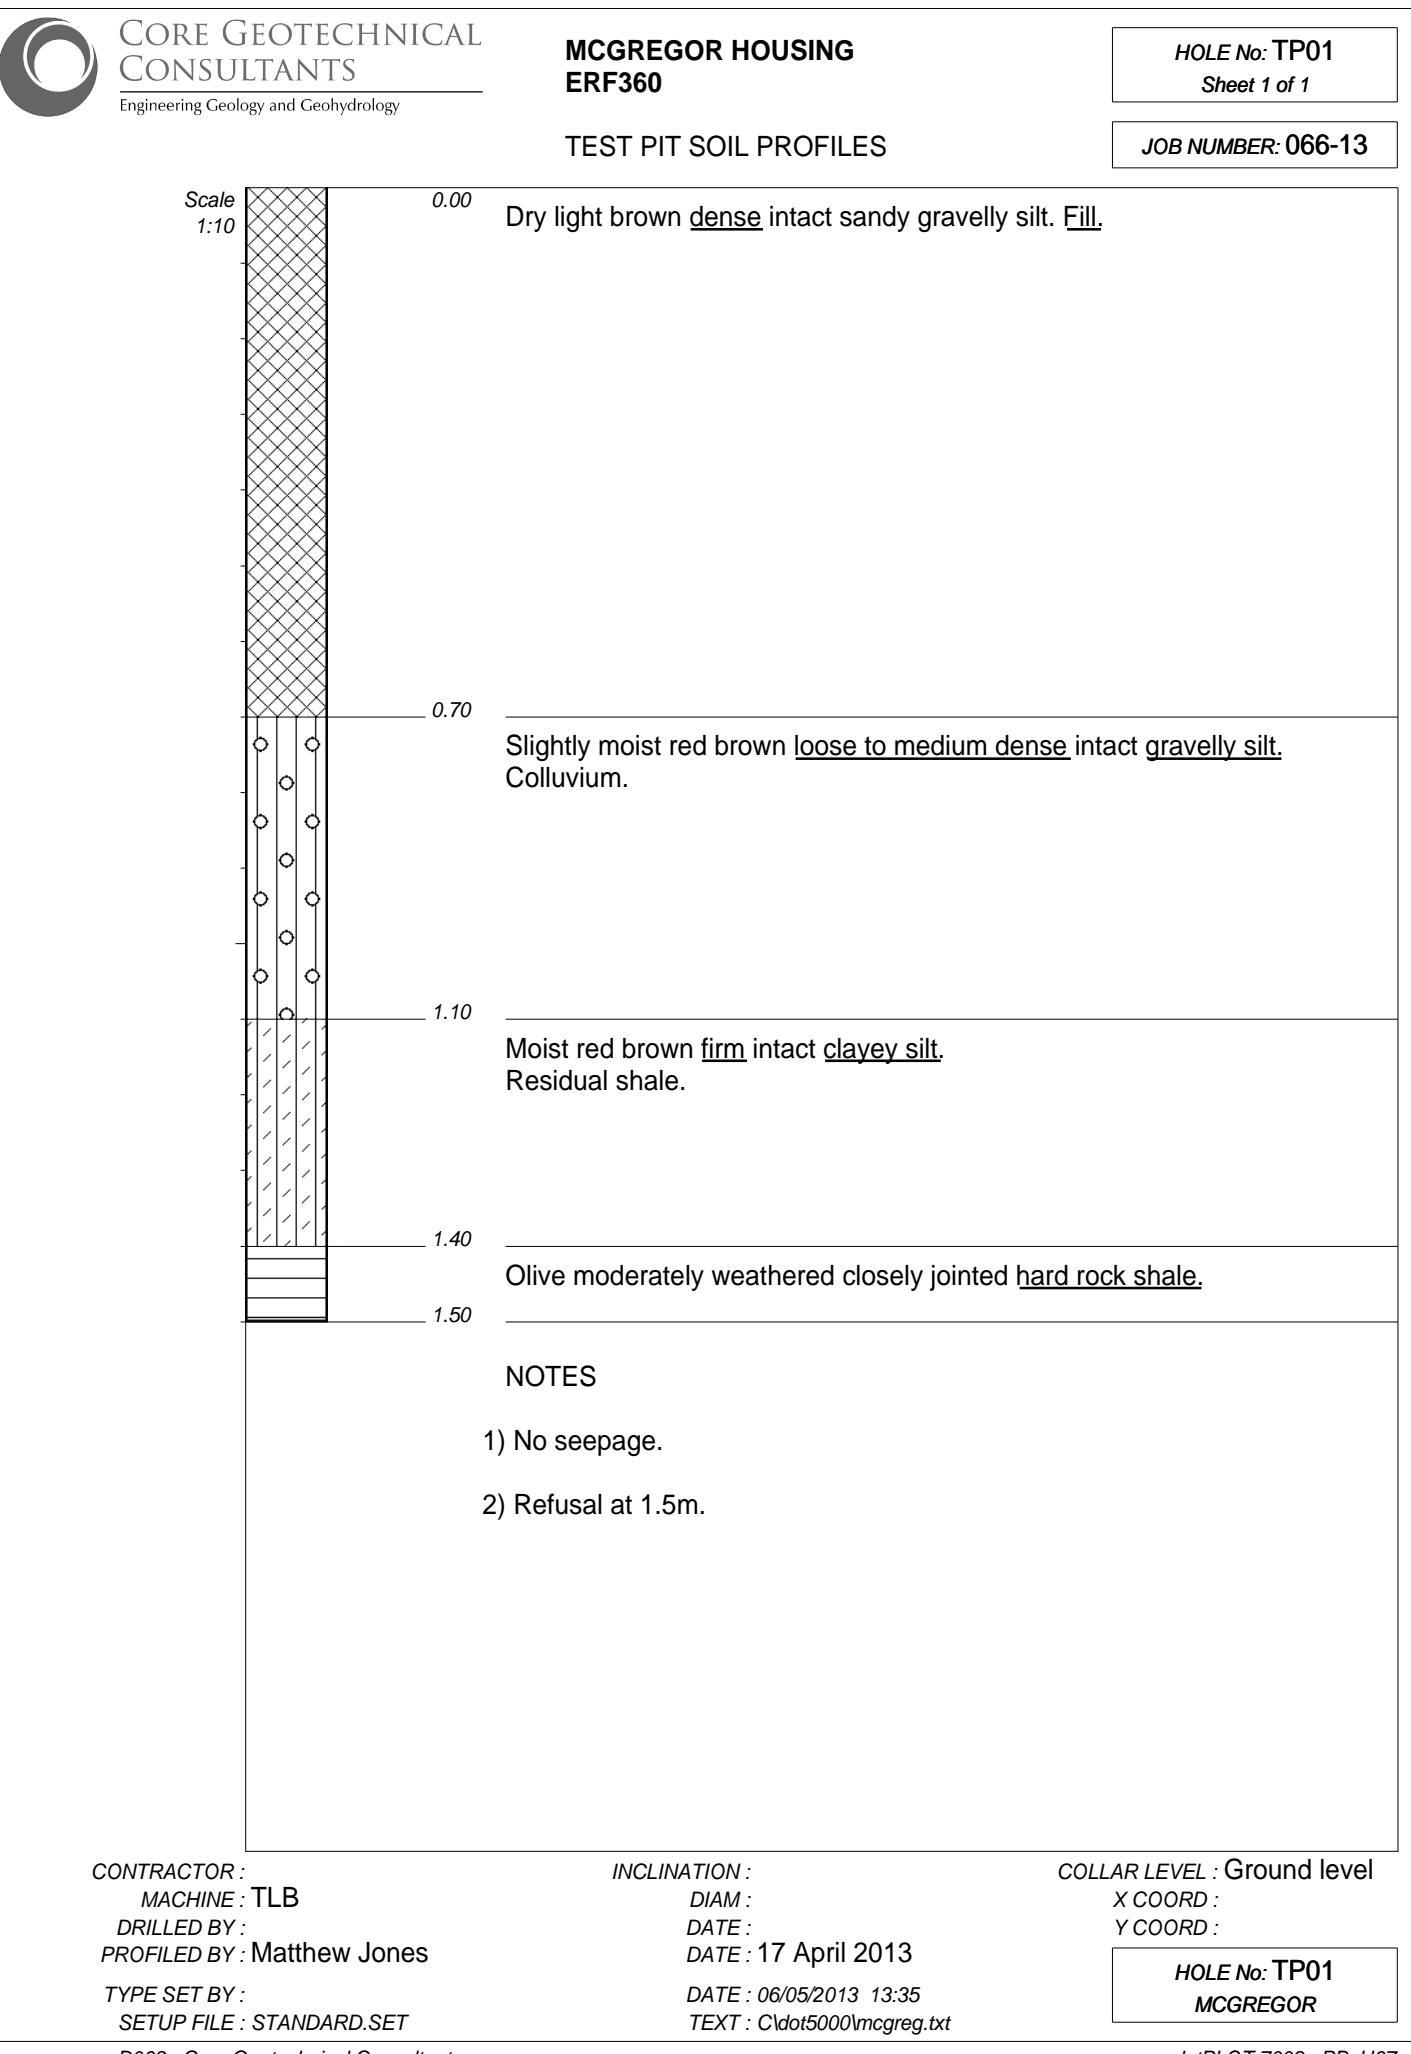
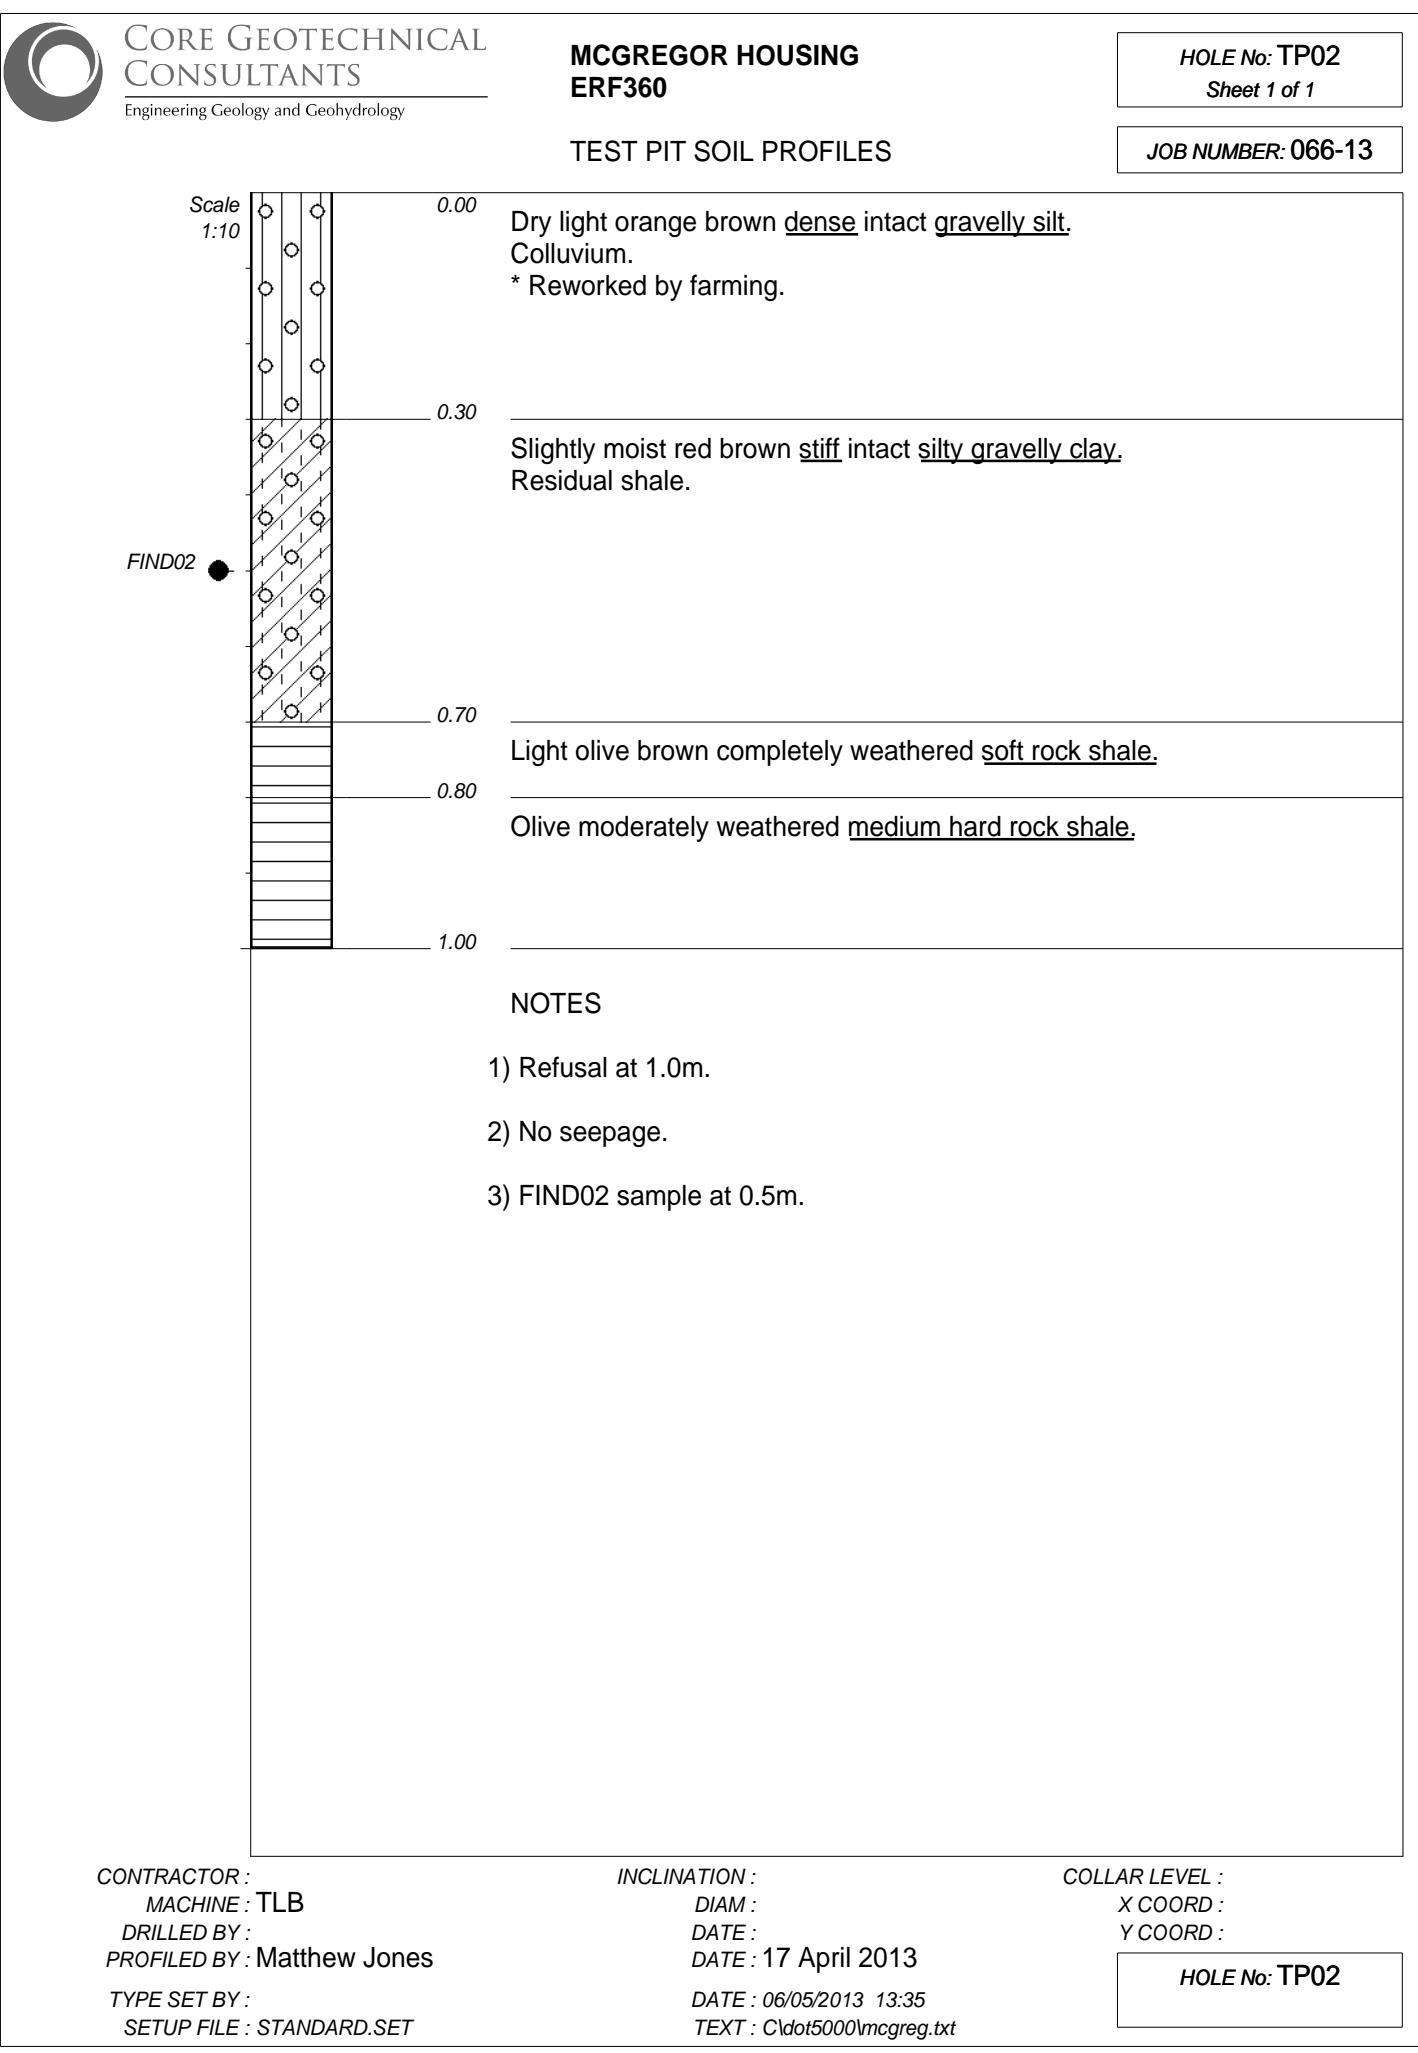
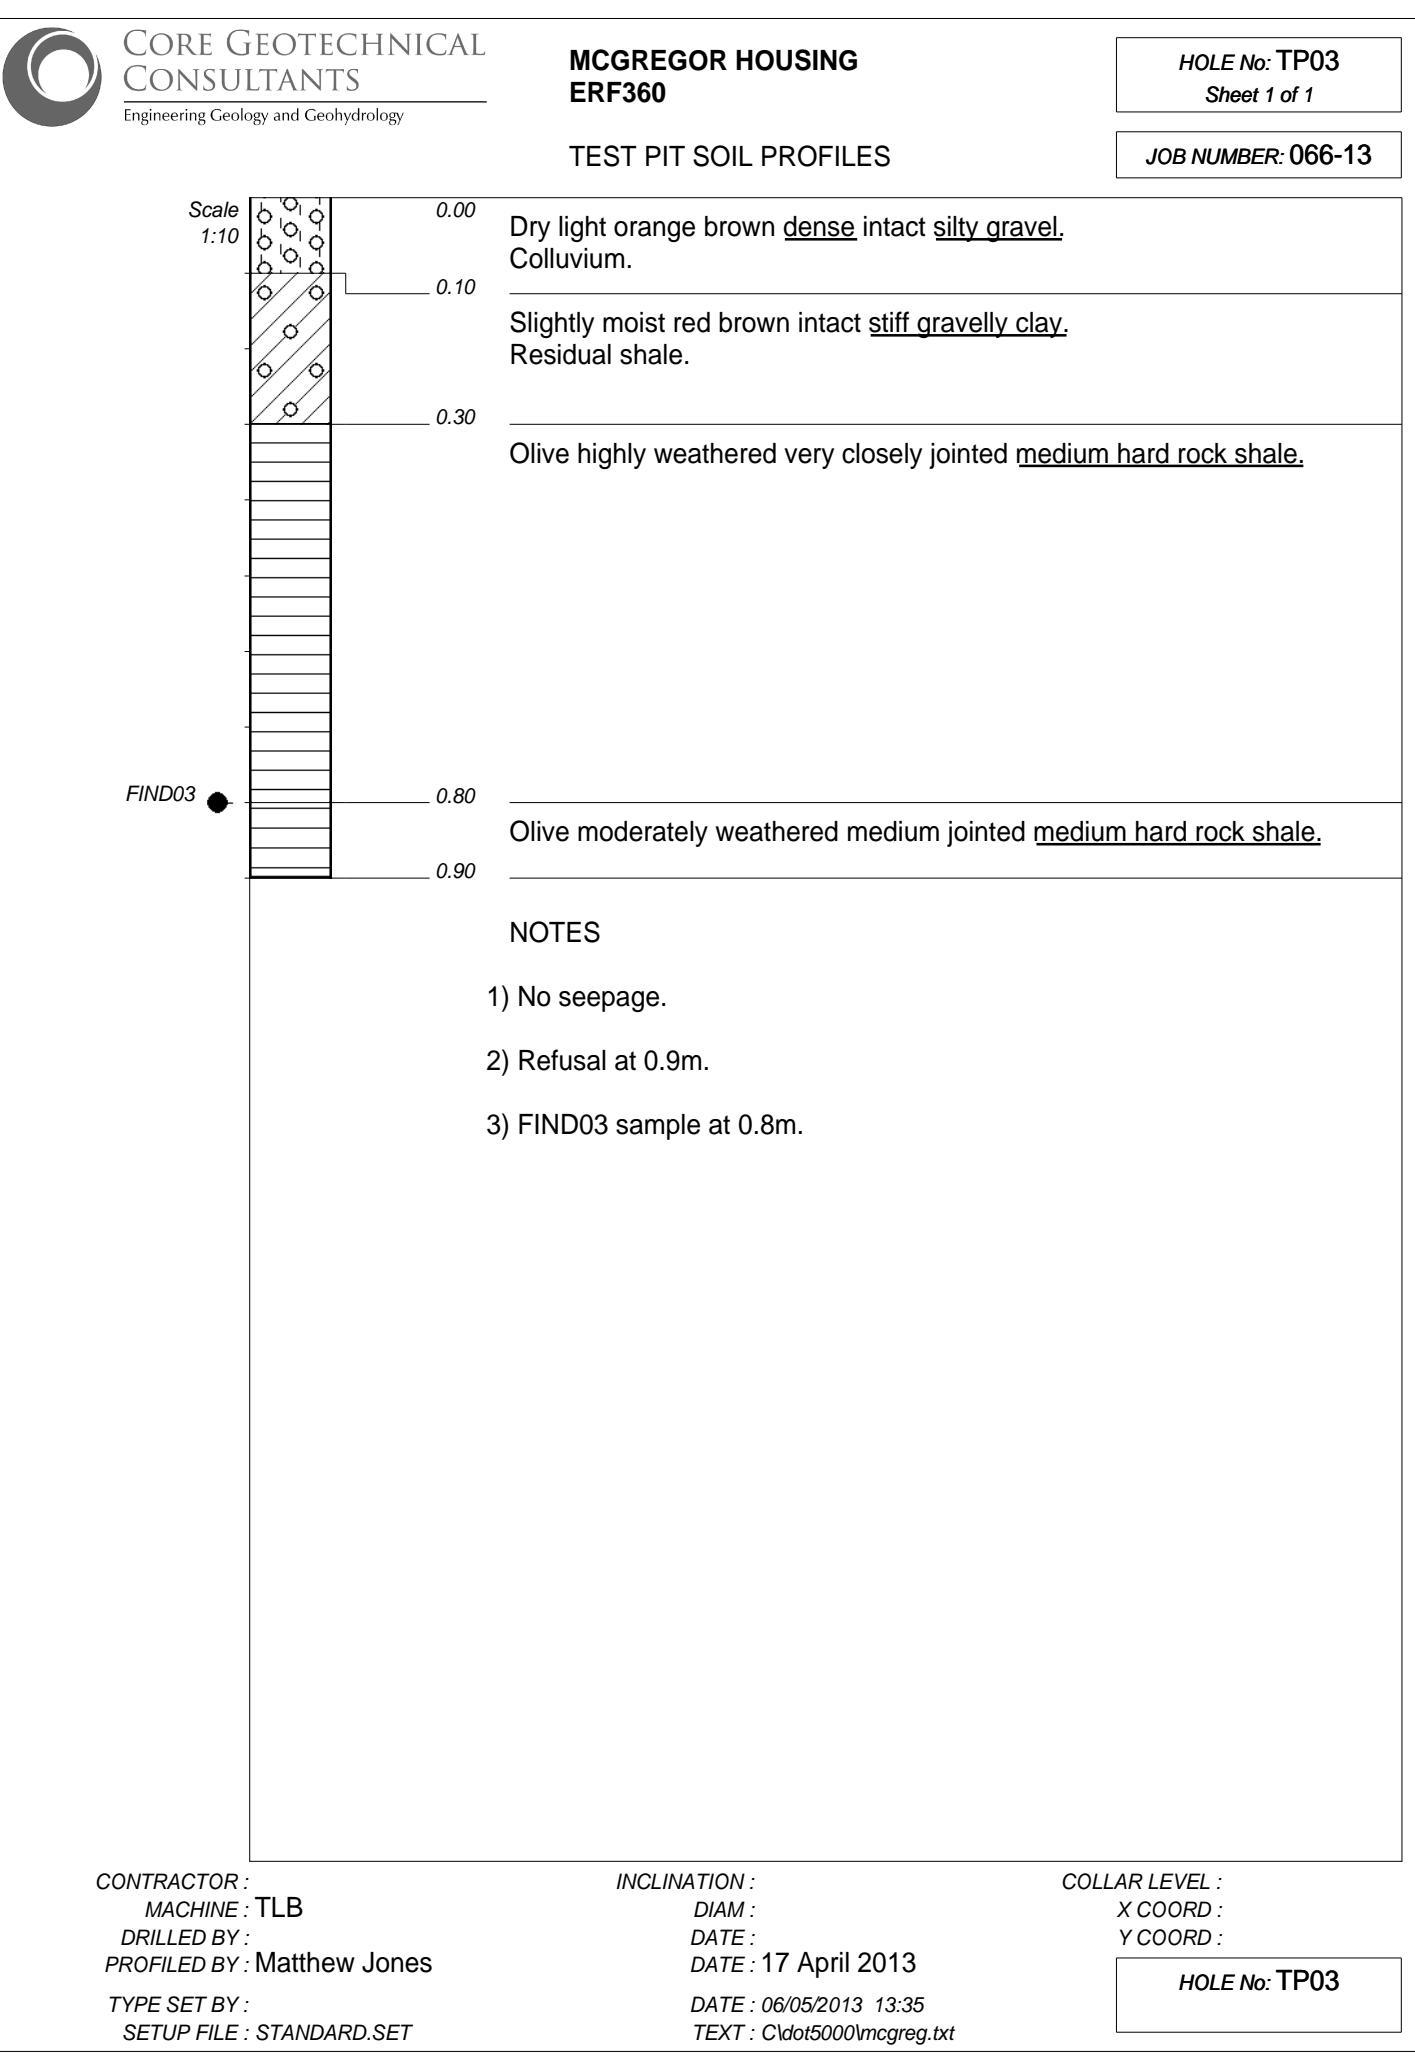
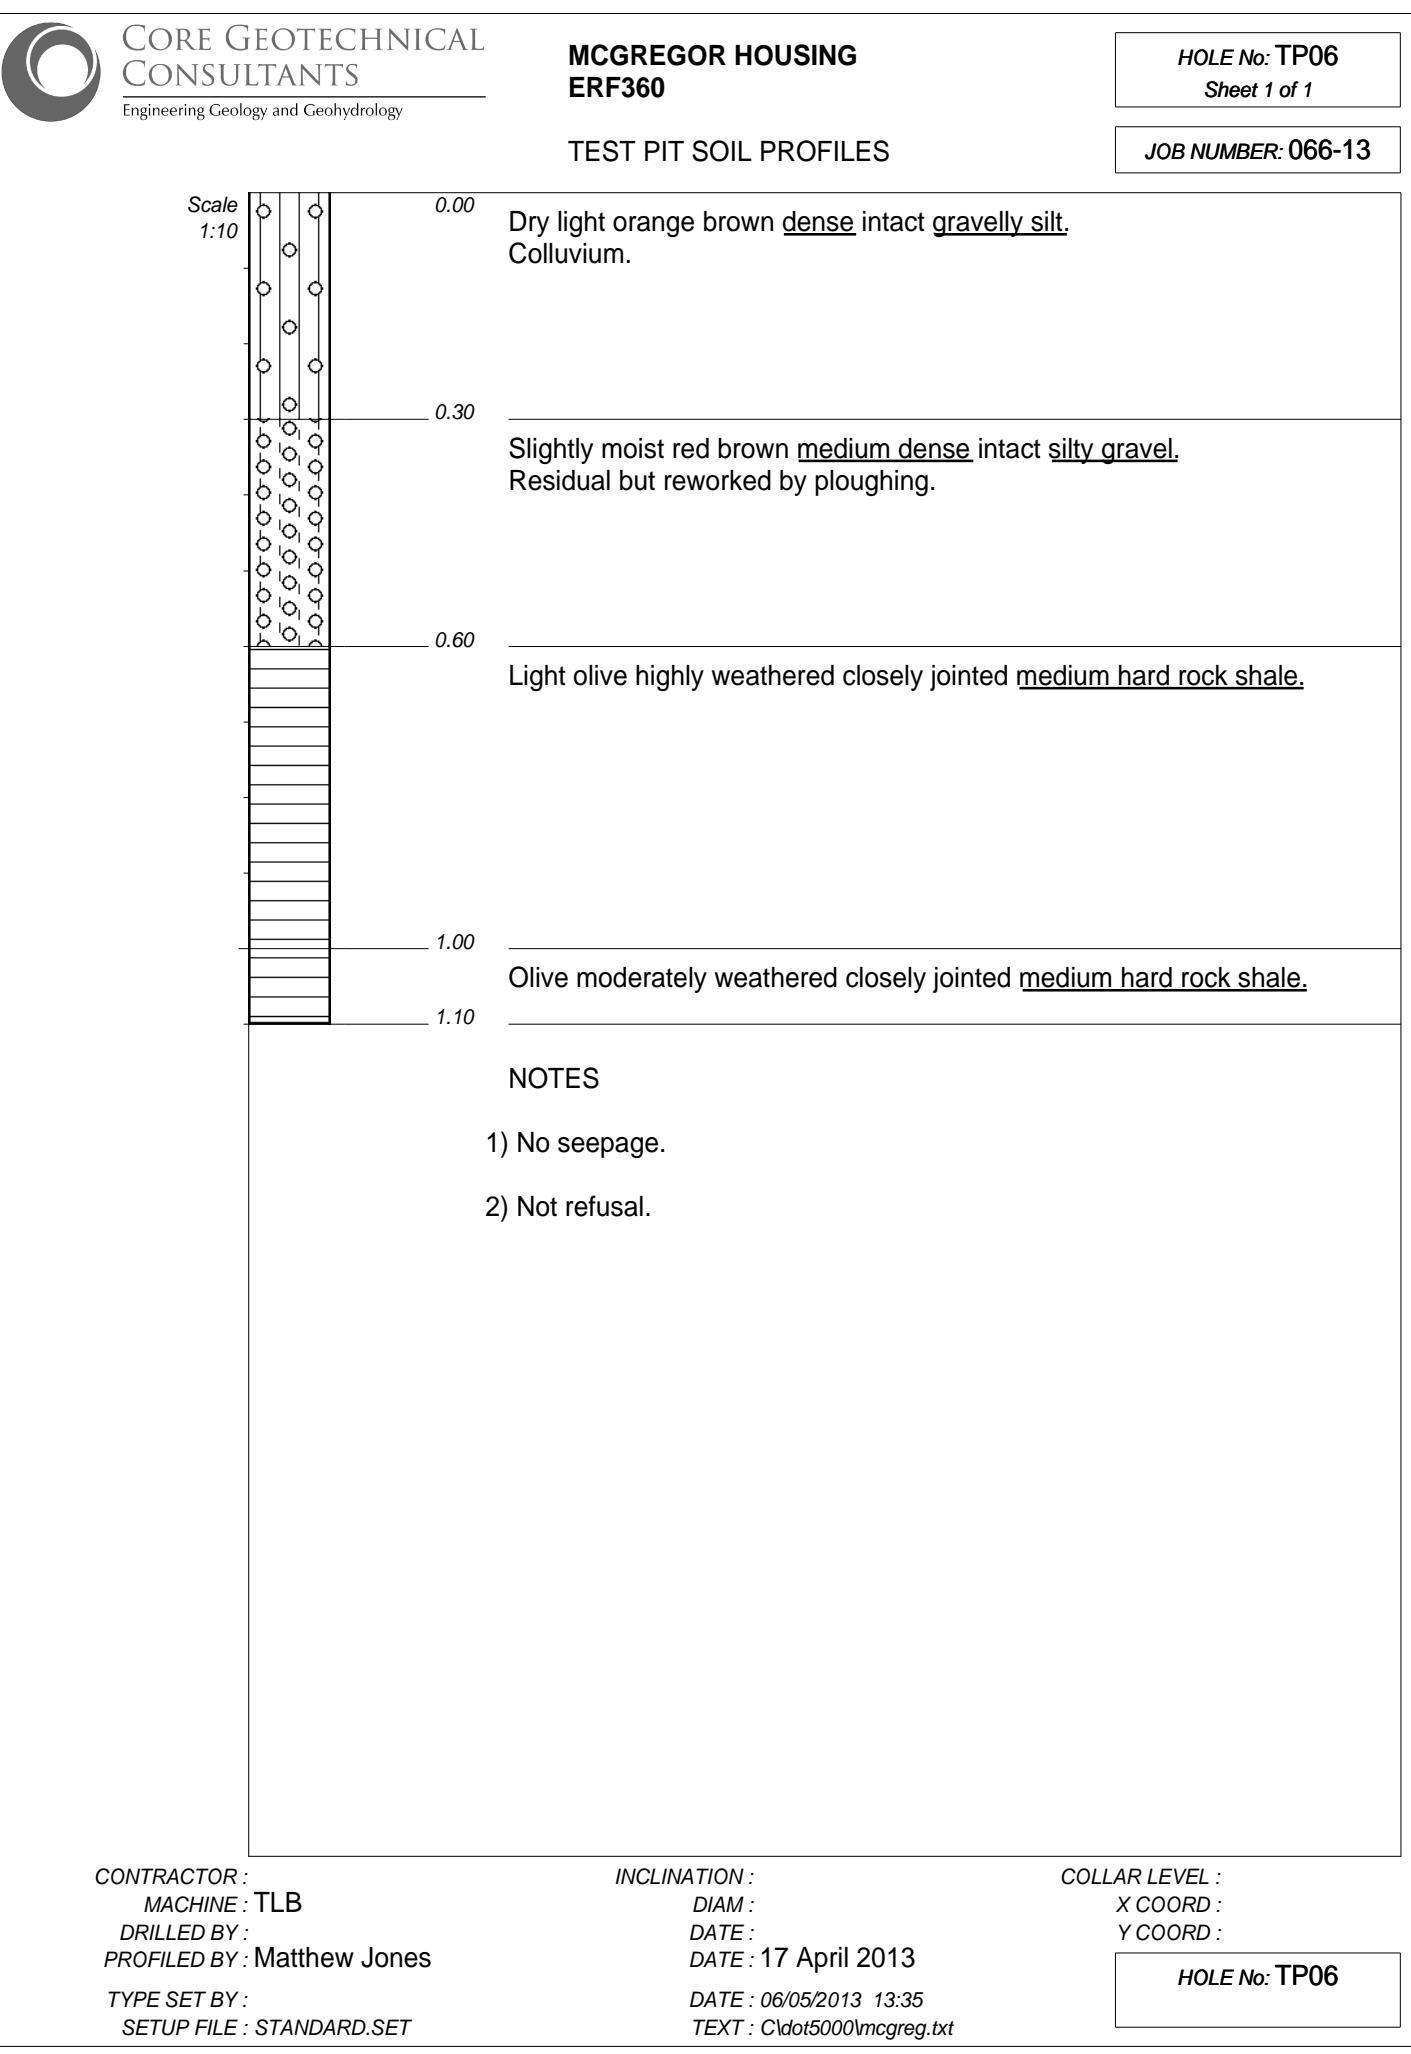
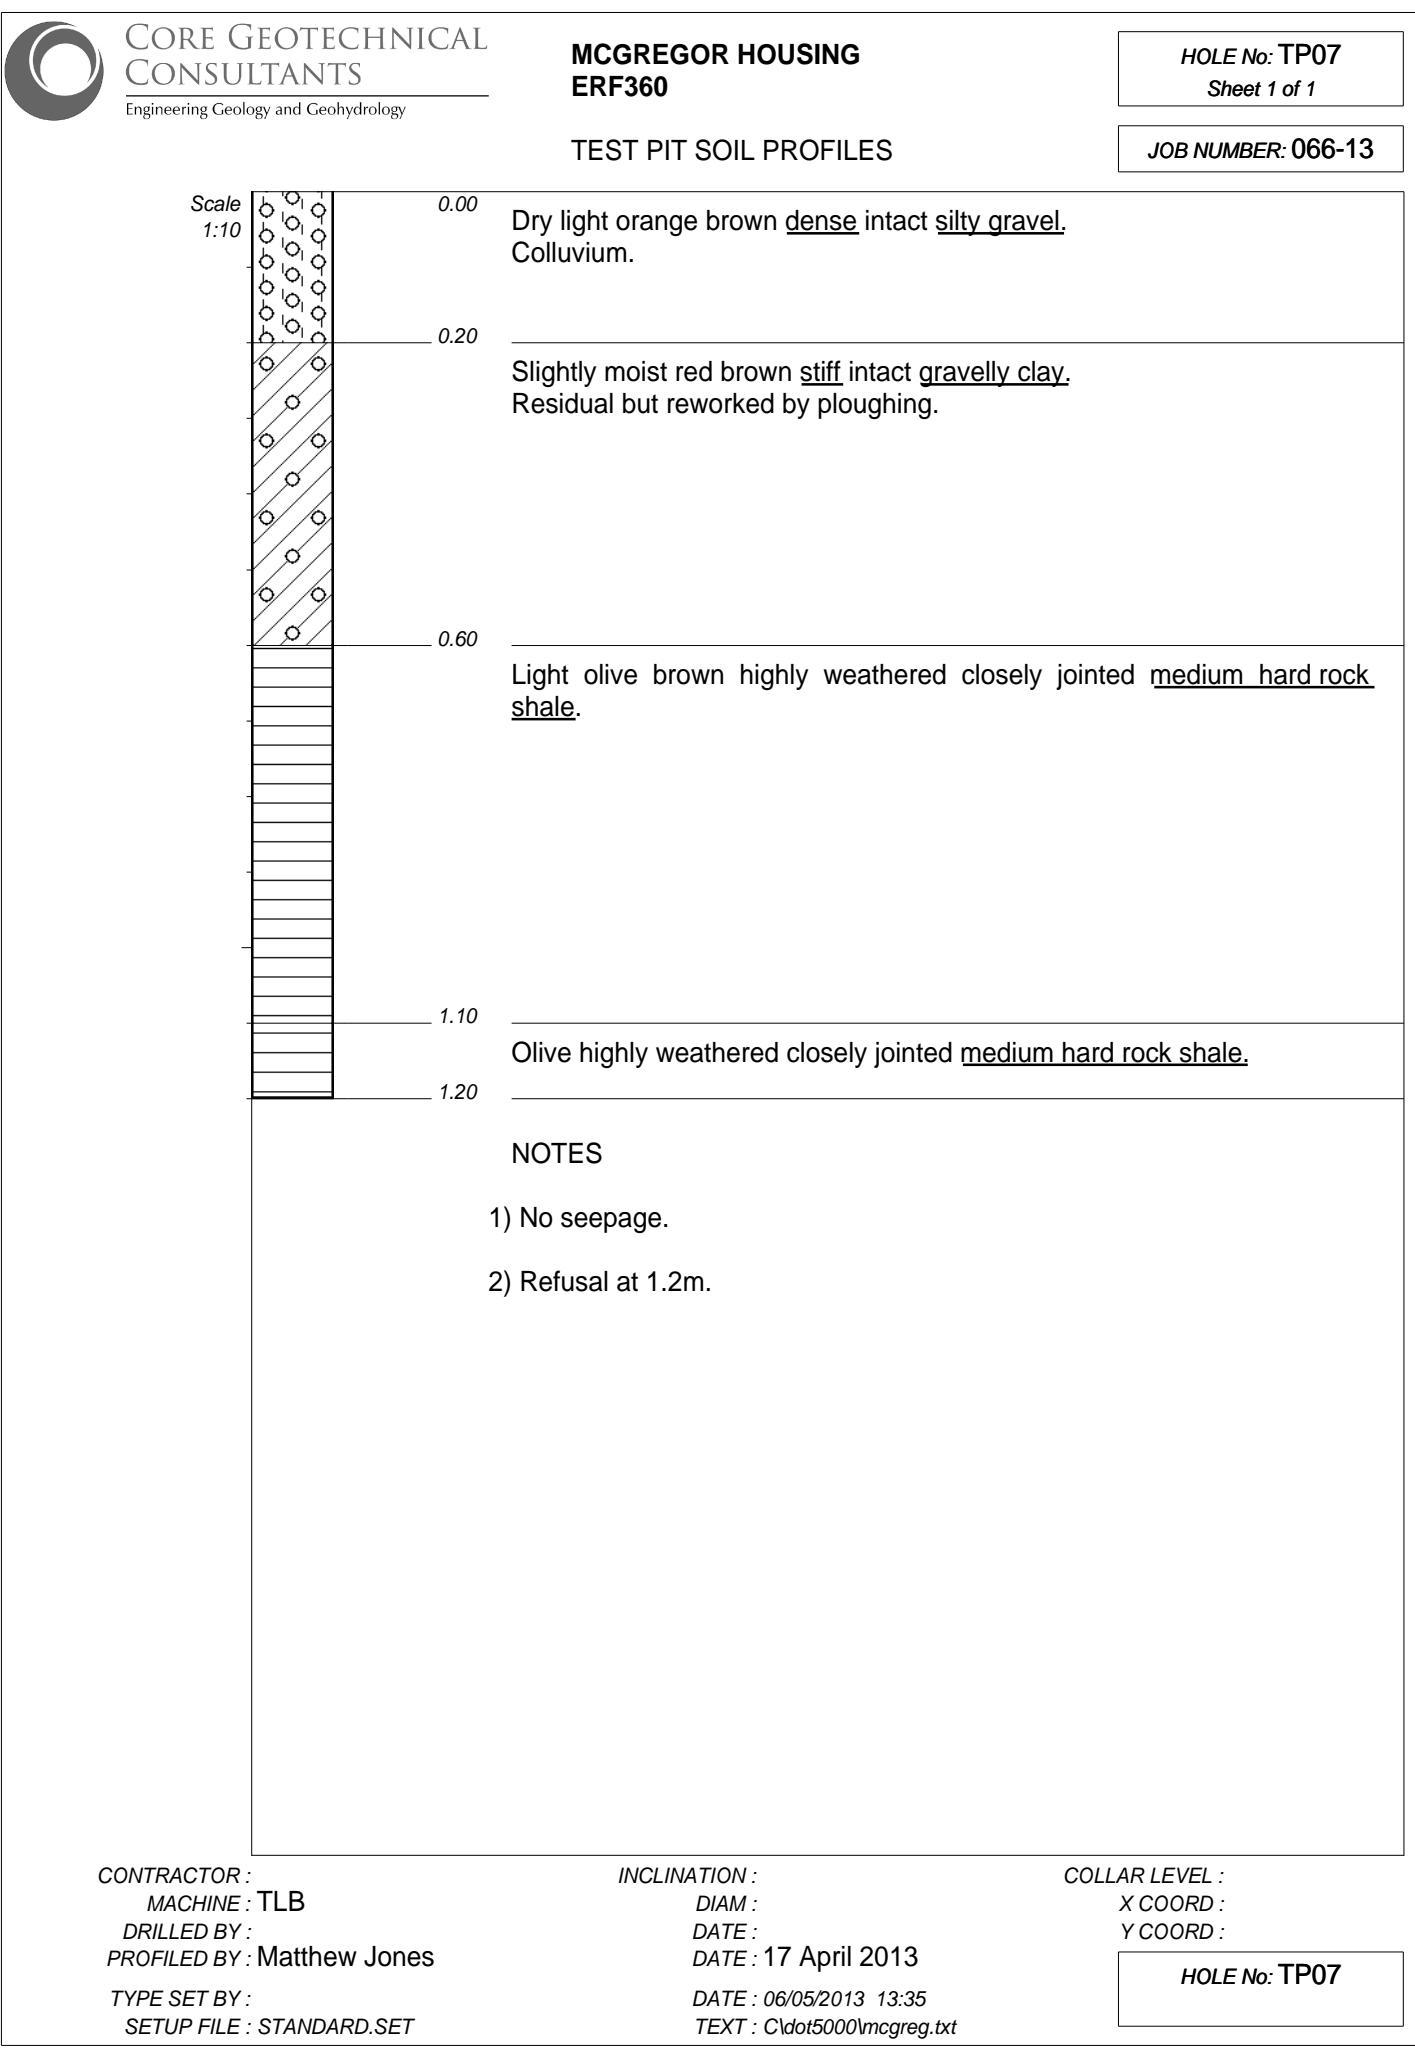
CORE GEOTECHNIC CONSULTANTS Engineering Geology and Geohydrology	CAL MCGREGOR HOUSING ERF360	HOLE No: TP04 Sheet 1 of 1
	TEST PIT SOIL PROFILES	JOB NUMBER: 066-13
$\begin{array}{c c} Scale & & O_1 \\ 0 & O_1 \\ 1:10 \\ 0 & O_1 \\ 0 \\ 0 \\ 0 \\ 0 \\ 0 \\ 0 \\ 0 \\ 0 \\ 0 \\ $	Dry light orange brown <u>dense</u> intact <u>silty gravel</u> . Colluvium.	
	Dry white <u>very dense</u> intact <u>gravelly silt</u> . Pedogenic hardpan calcrete.	
	NOTES	
	1) No seepage.	
	2) Refusal at 0.2m.	
CONTRACTOR : MACHINE : TLB	INCLINATION : CO DIAM :	DLLAR LEVEL : X COORD :
PROFILED BY : PROFILED BY :	DATE : 17 April 2013	Y COURD : HOLE No: TP04
TYPE SET BY : SETUP FILE : STANDARD.SET	DATE : 06/05/2013 13:35 TEXT : C\dot5000\mcgreg.txt

ORE GEOTECHNI ONSULTANTS ineering Geology and Geohydrology	CAL	MCGREGOR HOUSING ERF360	HOLE No: TP05 Sheet 1 of 1			
			TEST PIT SOIL PROFILES	JOB NUMBER: 066-13			
Eng	Scale 1:10 Scale 1:10 Scale 1:10 Scale 1:10 Scale 1:10 Scale 1:10 Scale 1:10 Scale 1:10 Scale 1:10 Scale Scale 1:10 Scale	0.00 - 0.20 - 1.10 - 1.20 1 2	TEST PIT SOIL PROFILES JOB NUMBER: 066- Dry light brown dense intact gravelly silt. Colluvial. Light olive highly weathered very closely jointed medium hard rock shale Image: Collumn for the state of				
CONT I DR PRO TYPP	TRACTOR : MACHINE : TLB ILLED BY : FILED BY : Matthew Jones E SET BY :	5	INCLINATION : DIAM : DATE : DATE : 17 April 2013 DATE : 06/05/2013 13:35	COLLAR LEVEL : X COORD : Y COORD : HOLE No: TP05

Near-surface colluvial soils essentially comprise dense gravelly silts to silty gravels, which are up to 0.70 m thick. These are underlain by residual shale soils that consist mainly of firm to stiff gravelly silty clays up to 1.4 m thick. Calcrete was intersected in test pit TP4 but is expected to be a relatively thin horizon just above the rockhead contact.

The soil horizons are underlain by shales (rock) where the rock depth varies from surface outcrop to 1.4 m depth. The rockhead depth is seen to increase from the north eastern side of the site to the south western portion.
